# Failure at the Factory

A trio of wartime incidents causes the loss of four aircraft and six lives

NICHOLAS A. VERONICO

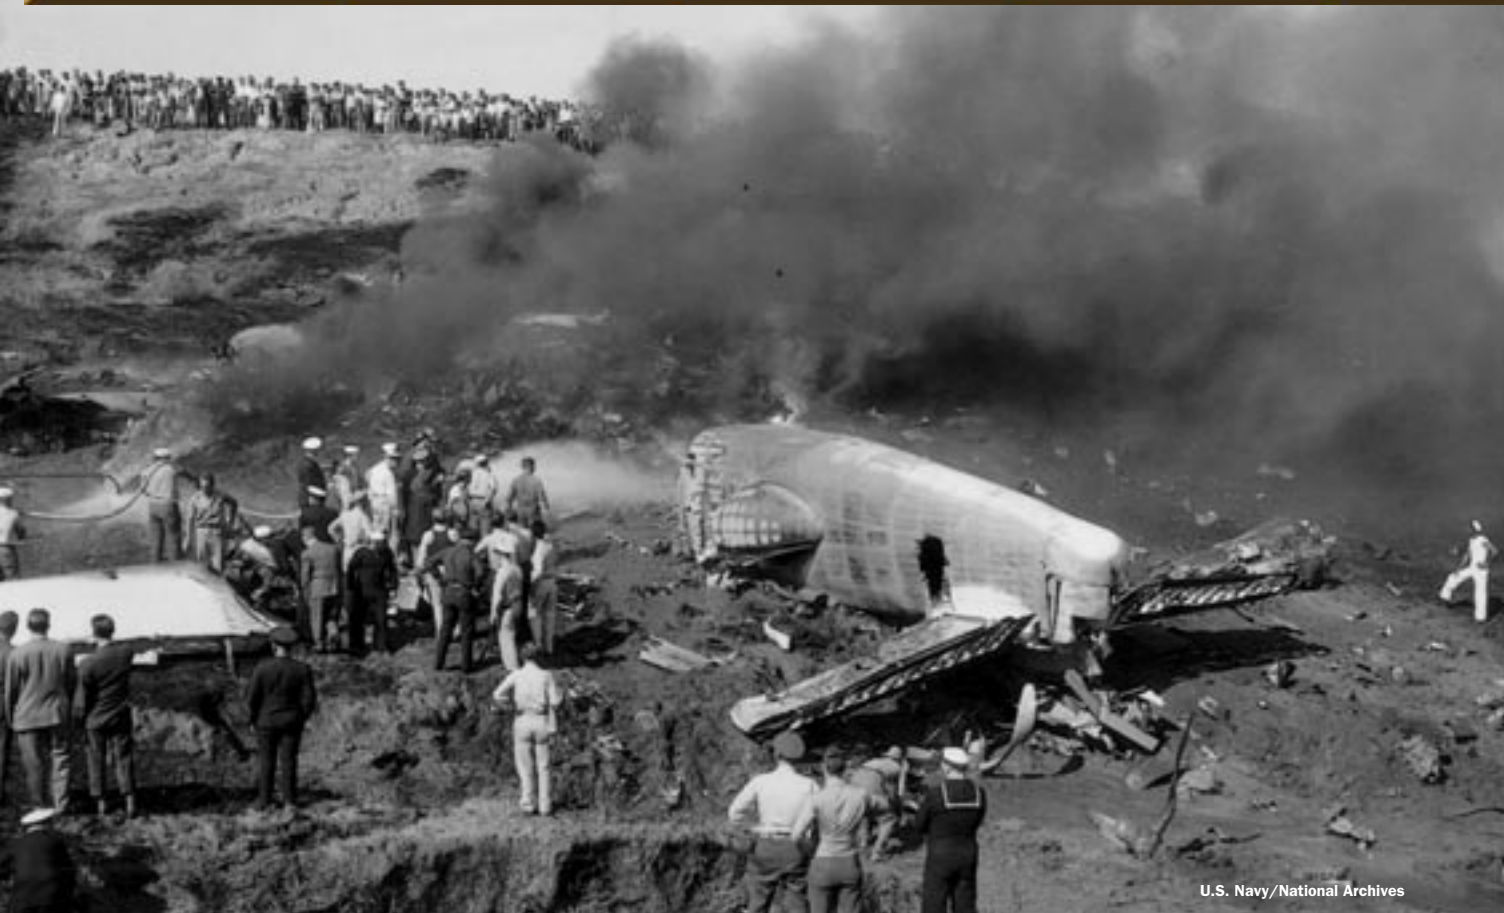
**Lead Photo: PB4Y-2 BuNo 59554, flown by a Consolidated Vultee Aircraft civilian crew who lost their lives when factory workers failed to install 98 bolts holding on the left outer wing panel. Installation of the missing bolts was signed off by an inspector.**

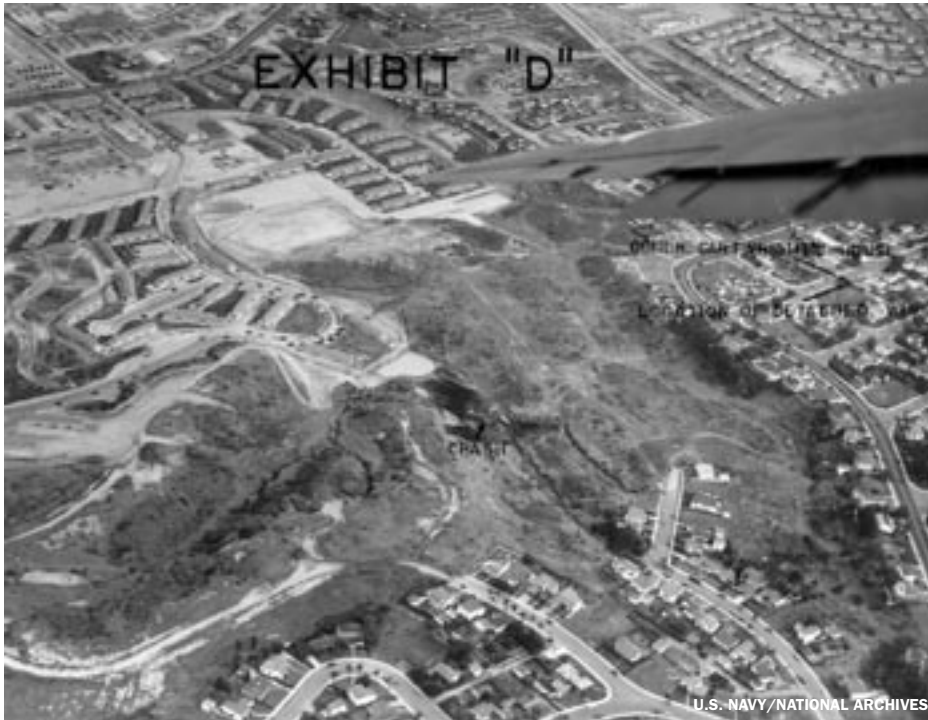
**Scene of the crash showing the short distance between where the detached wing panel landed and the crash site. The area of the crash has since been built up with houses.**

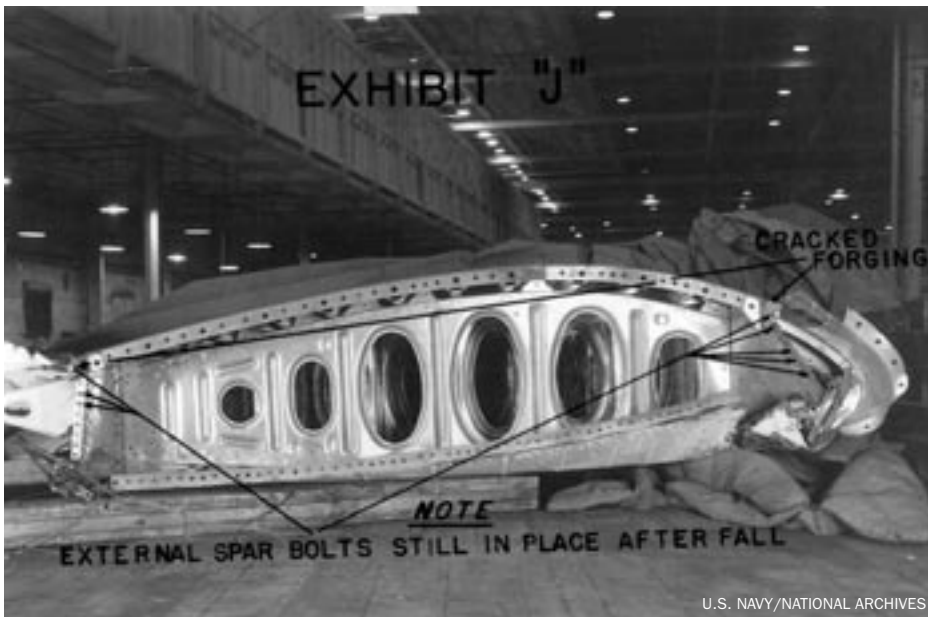
**After recovery from in front of the Kingsley St. home, the left outer wing panel was thoroughly examined. It was quickly determined that workers failed to connect the panel by omitting 98 bolts. Only the four spar attach bolts were installed, having failed shortly after takeoff.**

The port outer wing panel was described to have "twisted like a

leaf," striking the roof of the front bedroom of the home at 3121 Kingsley St. in Loma Portal. The wing panel came to rest on the lawn. The single-story residence was owned by Cmdr. A.B. Cartwright, and at the time of the accident, his wife was in the backyard watching the whole incident unfold. Houseguests of the Cartwrights were inside the home, but they were not injured. It was now 12:23 p.m.

In the aftermath of the crash, the wreckage was hauled away for inspection. Two days later, on November 24, Consolidated Vultee officials announced that four employees (C.R. Alexander, H.B. Hendryz, J.E. Lahyer, and J.C. Hedgpeth) were terminated. Either they were directly responsible for installing bolts that connected the outer wing panel to the wing center section, or they were inspectors who had signed off on the work (none of which had been done). Although the four spar bolts that had held the wing panel were in place, a post-crash inspection revealed that 98 additional bolts were missing and never installed. U.S. Navy officials immediately ordered an inspection of the wing panel attach points of all PB4Y-2 aircraft in service.

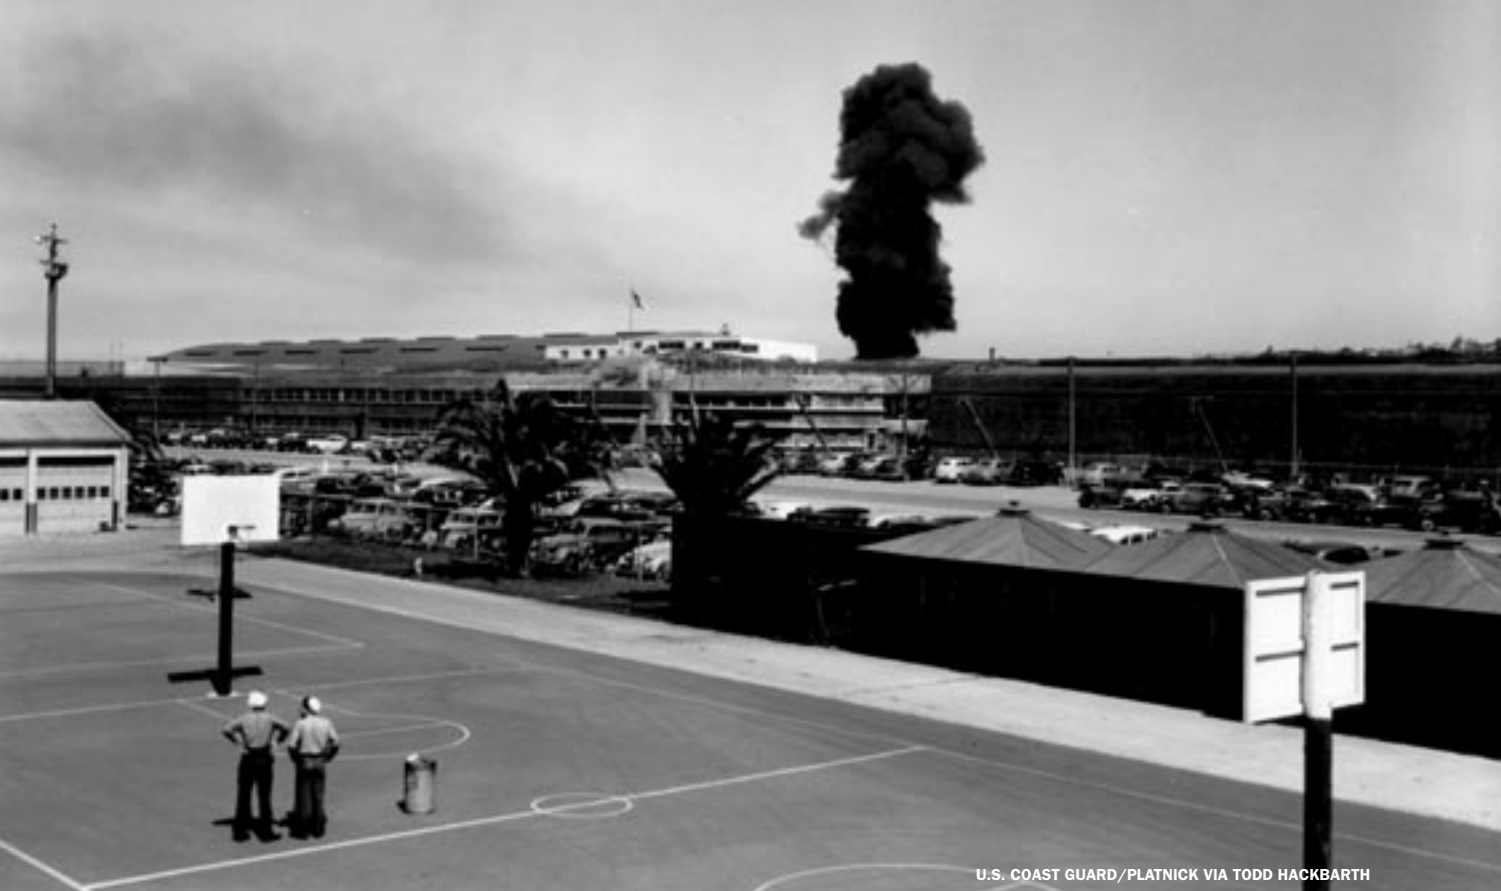
**The first sign of trouble: Smoke rises above the factories around Lindbergh Field as BuNo 59836 becomes fully engulfed in flames.**

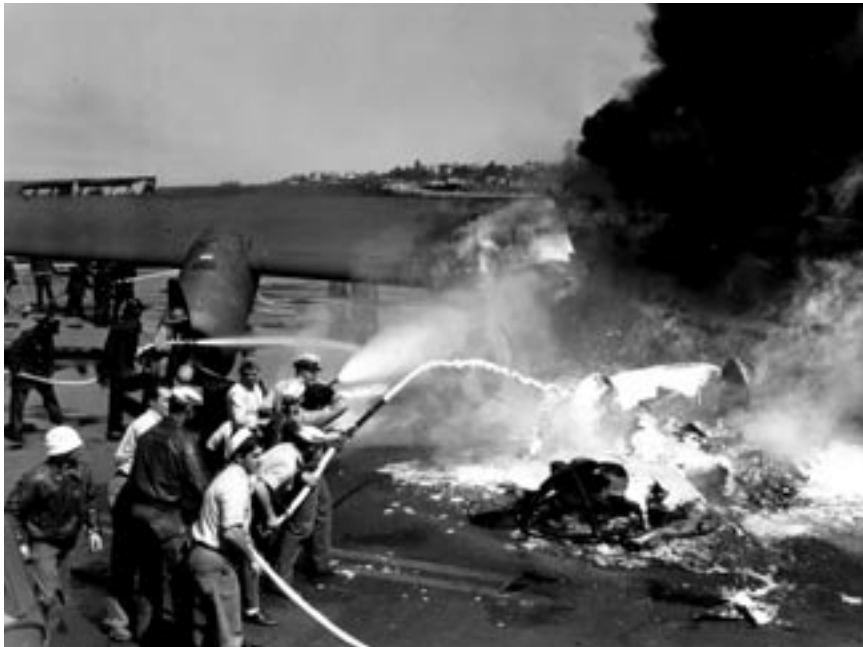
**Sailors, Coast Guardsmen, and factory workers try to extinguish the flames of 59836 after a Ryan Fireball crashed into it. Four of the PB4Y-2's crew escaped, one with serious injuries.**

With the wing folding up, Lake jumped from the aircraft and parachuted to safety. As Lake floated down, his FR-1 was torn to pieces. Momentum carried the craft further, spinning over Lindbergh Field, crashing into the fuselage of the Privateer occupied by Lt. Rietz and his crew. Rietz, Creed, and Brown were able to exit the aircraft without injuries. Aviation machinist mate Randall was not so lucky. He suffered first-, second-, and third-degree burns as well as mild lacerations.

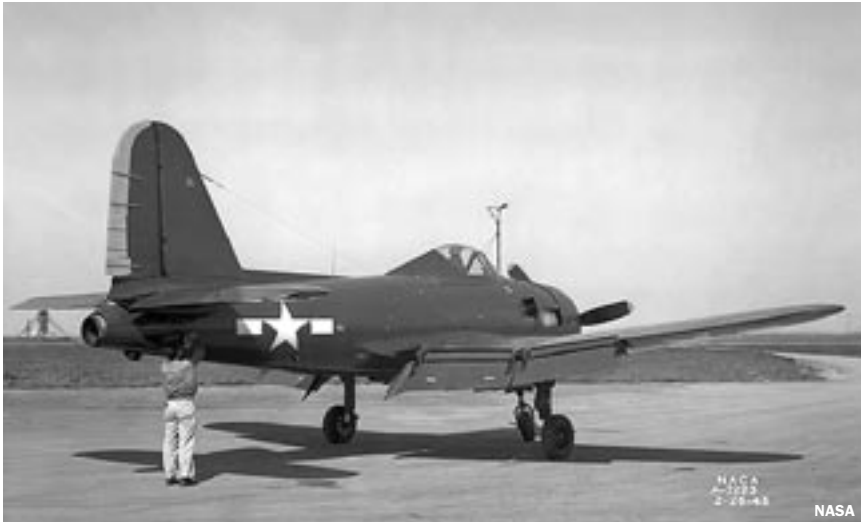
**A Ryan Fireball lost a wing, and the resulting wreckage dropped onto PB4Y-2 BuNo 59836 as it sat on the Lindbergh Field ramp. Ryan immediately added a skin doubler to the wing and looked at re-engineering the canopy release latch.**

As Lake flew over Lindbergh Field, the skin between the front and rear spars on the right wing tore off, and the airflow over the open hole caused the wing to disintegrate. A second plausible theory claims the canopy departed in flight and knocked off the tail.

Both aircraft were completely destroyed. To address the accident’s probable cause, Ryan added a .064-inch skin doubler between the wing spars and experimented with a new canopy and canopy release mechanism in tests in the 40-by 80-foot wind tunnel at the National Advisory Committee for Aeronautics’ (NACA, the forerunner of today’s NASA) Ames Research Center in Mountain View, California.

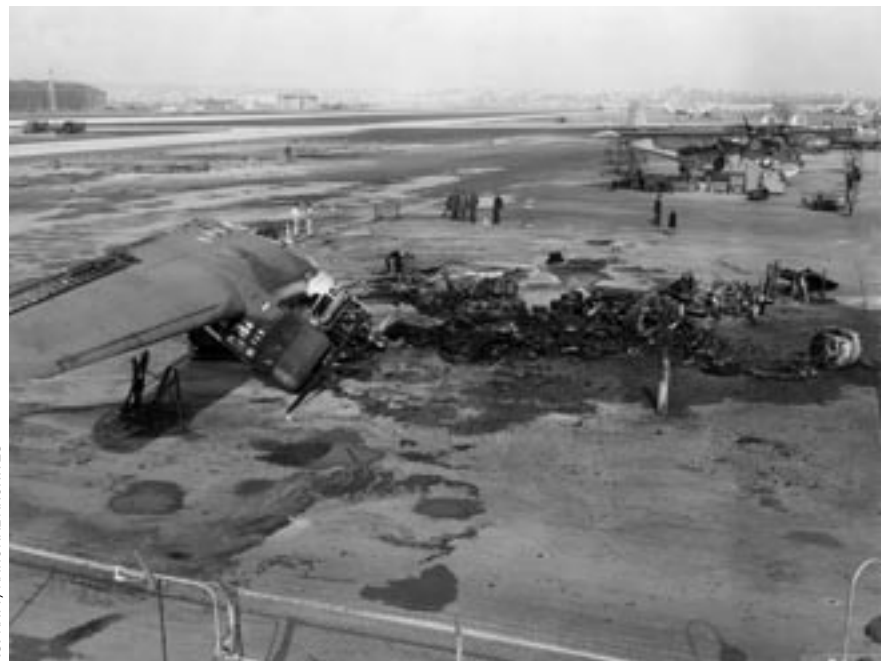
Zimmerman to remove the port battery solenoid, which is located 14 inches below the cockpit floor. At 11:59 p.m. local time, Fisher was attempting to remove the nut that attaches the positive battery cable to the solenoid. Fisher, not a trained electrician, had begun working without disconnecting the battery. A series of hydraulic lines was 3 inches above the nut. As Fisher rotated the socket’s ratcheting handle, it punctured a hydraulic line, sending fluid over the battery and solenoid. The fluid ignited, and when help arrived Fisher was found outside the aircraft with severe burns. The entire aircraft burned, with only the number four engine considered salvageable.

The cause of the fire was officially listed as: “due to the assignment of a mechanic to perform electrical work which should be attempted only by a qualified electrician; an electrical short circuit between the battery terminal of the port battery solenoid and the adjacent hydraulic line. This condition resulted when [an] employee attempted to disconnect the positive battery cable terminal, at the solenoid, with a metal wrench without disconnecting the battery.”

**When an unqualified mechanic attempted to remove a battery solenoid, he broke a hydraulic line. The subsequent fluid spill ignited with the results shown here. BuNo 59350, the first production PB4Y-2, was completely destroyed.**

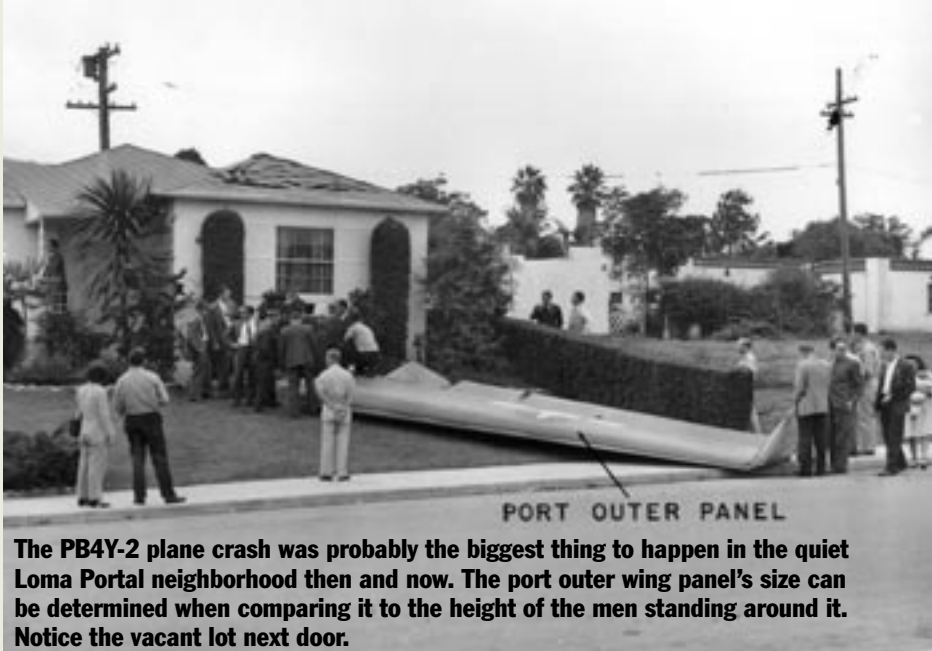
**The PB4Y-2 plane crash was probably the biggest thing to happen in the quiet Loma Portal neighborhood then and now. The port outer wing panel's size can be determined when comparing it to the height of the men standing around it. Notice the vacant lot next door.**

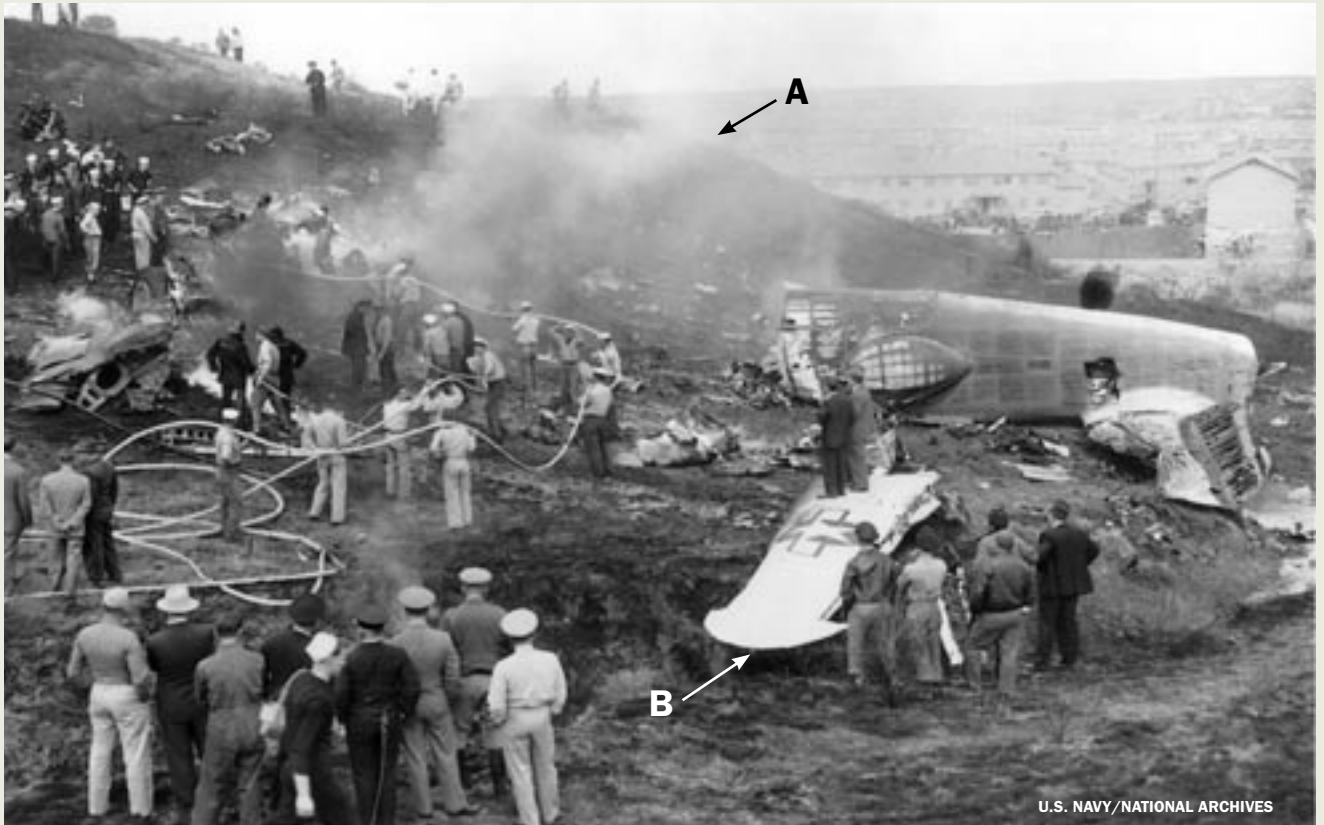
**Above:** At the impact site of BuNo 59554, Navy crews worked to rescue any possible survivors. Notice the hole chopped into the rear fuselage near the horizontal stabilizer. 'A' denotes the unusual shoulder of the hill, and 'B' shows the starboard outer wing panel lying across a drainage ditch.
