# Failure at the Factory

A trio of wartime incidents causes the loss of four aircraft and six lives

NICHOLAS A. VERONICO

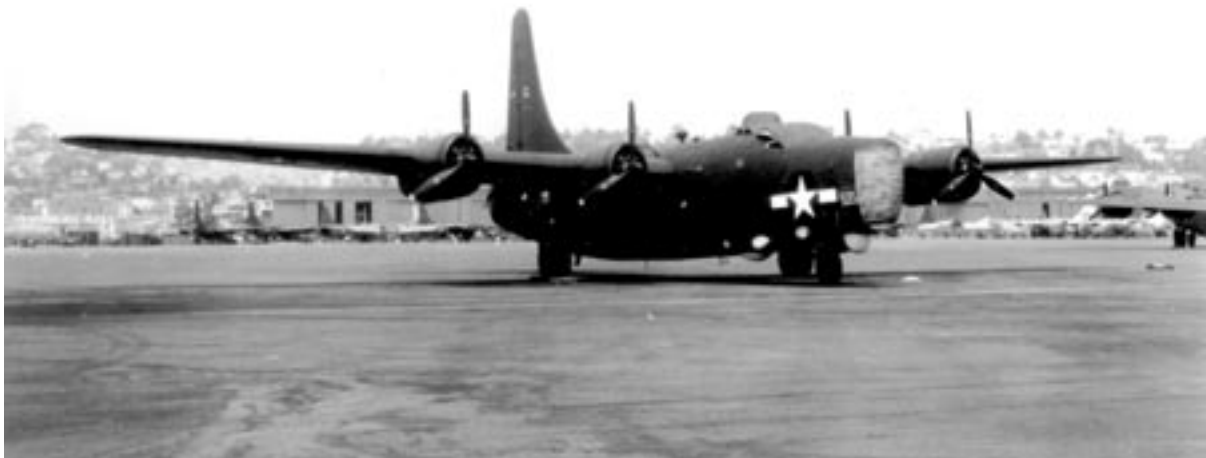
**A factory-fresh PB4Y-2 is seen on the ramp at Lindbergh Field, San Diego. Notice that the aircraft has been fitted with an aerodynamic covering over the location where the nose turret will be installed. This is the configuration of BuNo 59554 when it took off on November 22, 1944.**

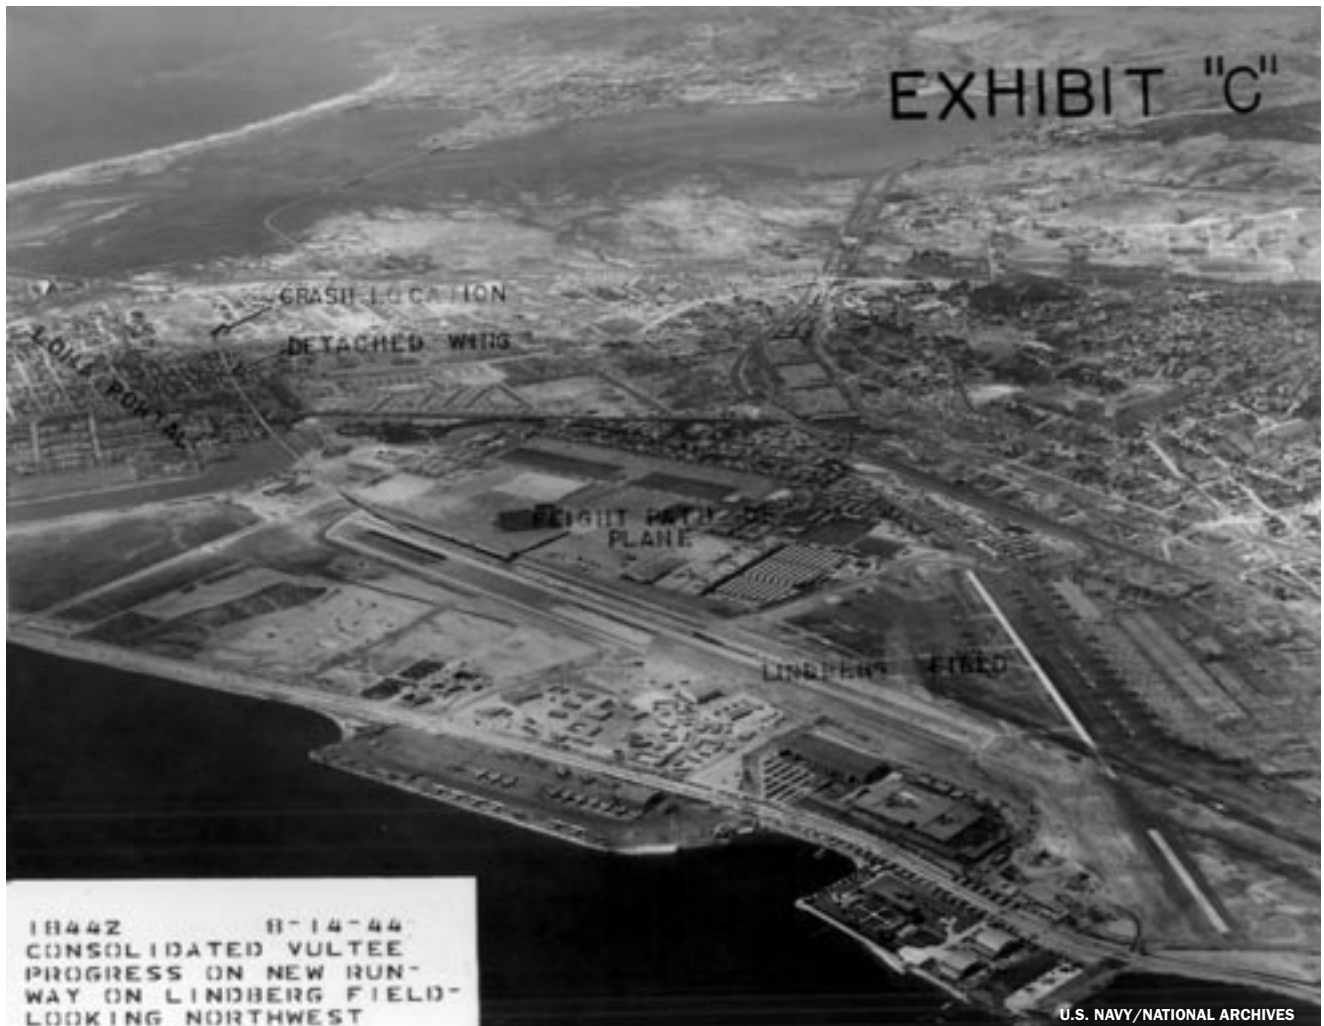
**Aerial view showing San Diego Bay, Lindbergh Field, the flight path of BuNo 59544, the location of the wing, and the aircraft's final resting place.**

the runway. Climbing for altitude, the pilots heard a loud crack as the port outer wing panel tore away. The loss of the wing panel caused an asymmetric lift condition from which the pilots could not recover.

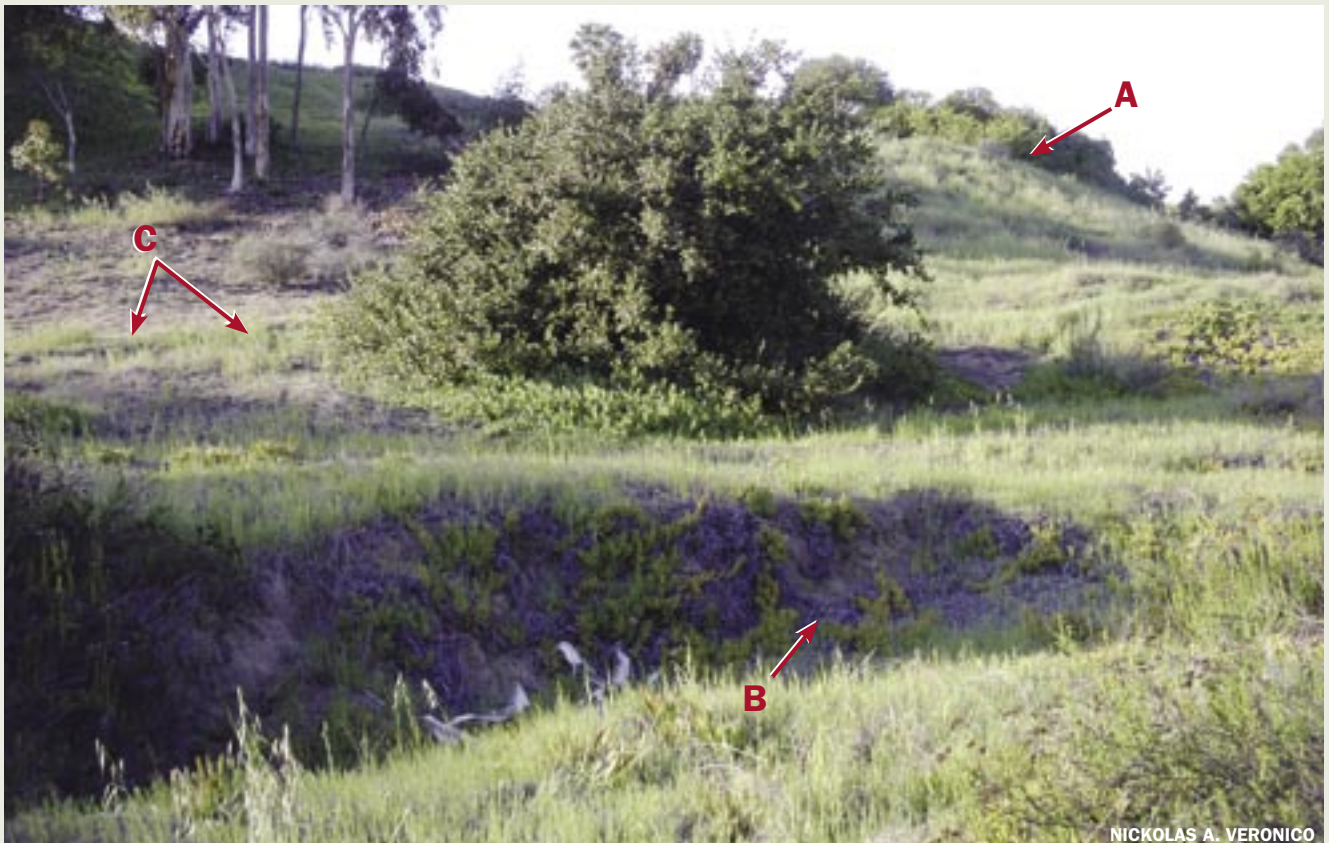
Comparing the photographs from the scene of the crash to today, you can still see the drainage ditch at the bottom of the ravine, and the shoulder-shaped hill below the Wise home. Gone are the Navy barracks, replaced by homes, and in the distance a Home Depot store.

**Below:** The crash site today: 'A' is the shoulder of the hill leading up to Oleander Dr. The Navy barracks were located behind this hill. 'B' shows the drainage ditch, and 'C' marks an area where debris from the crash was found 60 years after the event.
